COUPLE6 ALIGNMENT REPORT

Machine Name MOTOR PUMP 160KW. PP2
Company Name Amita (Thailand)
Location
Address

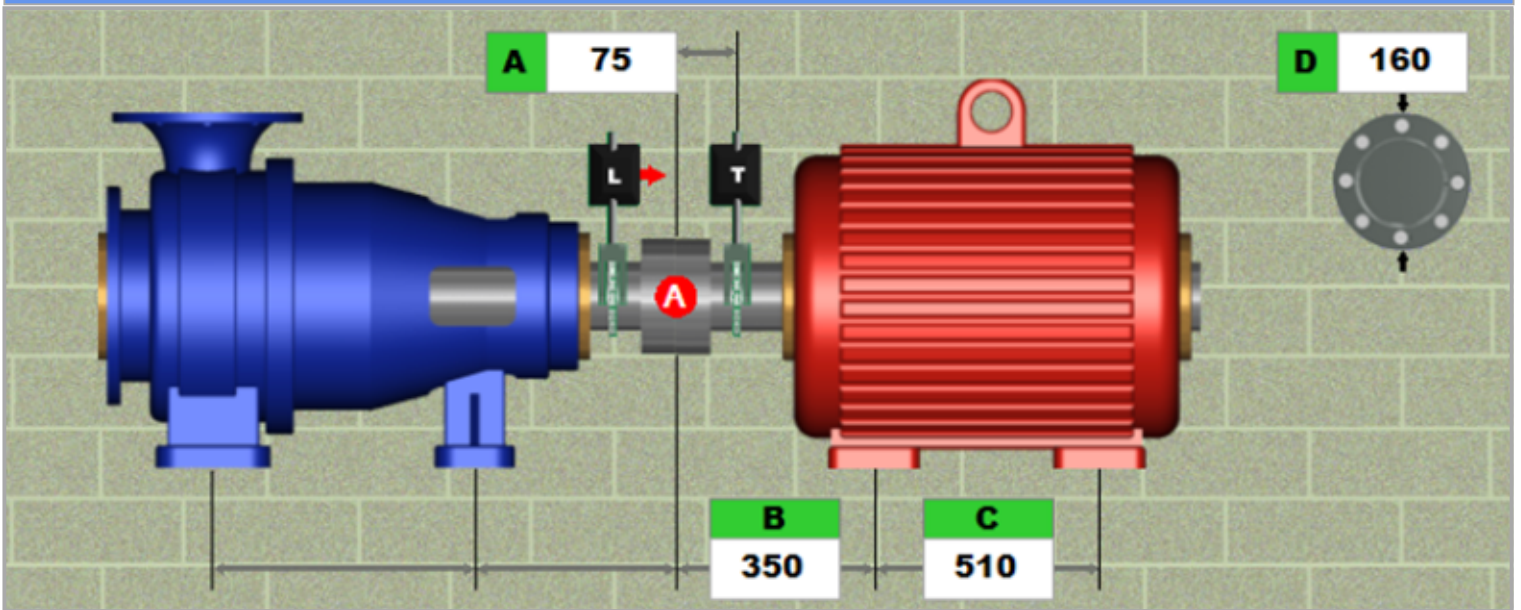
MACHINE SETUP

OFFSET = mm, ANGLE = mm/100mm

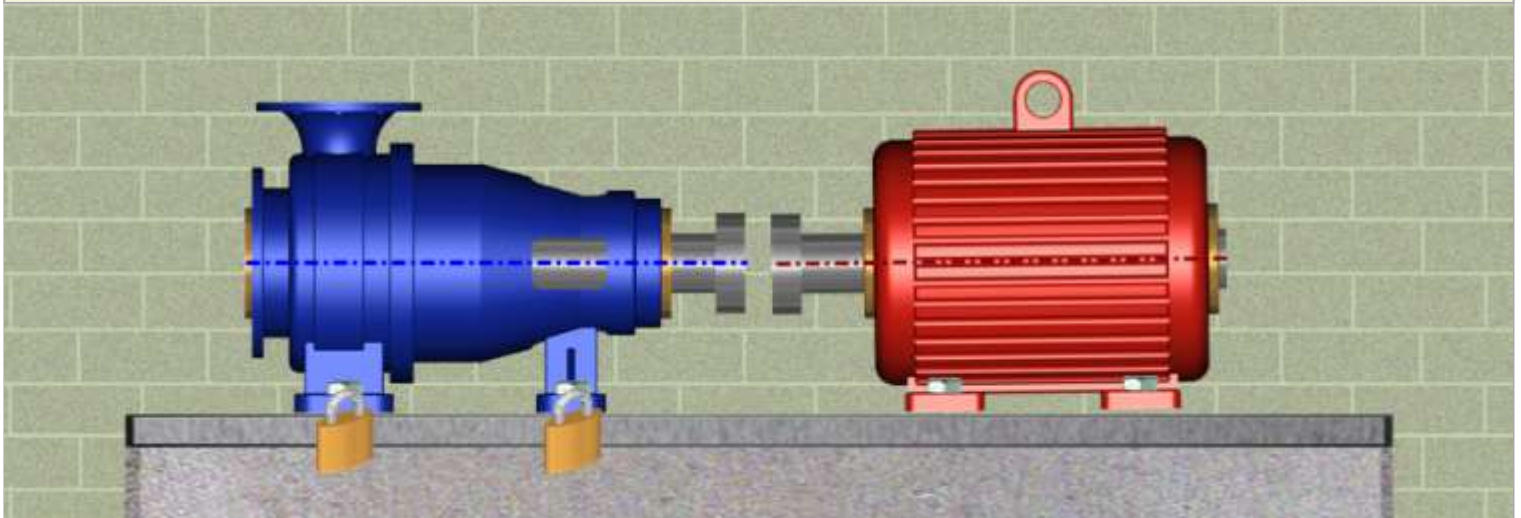
SIDE VIEW / VERT.

GAP

0.02

RPM	TOLERANCES	
	ACCE...	EXCEL...
1200+		
OFFSET	0.10	0.06
ANGLE	0.08	0.05
GAP	0.13	0.08

OFFSET

-0.01

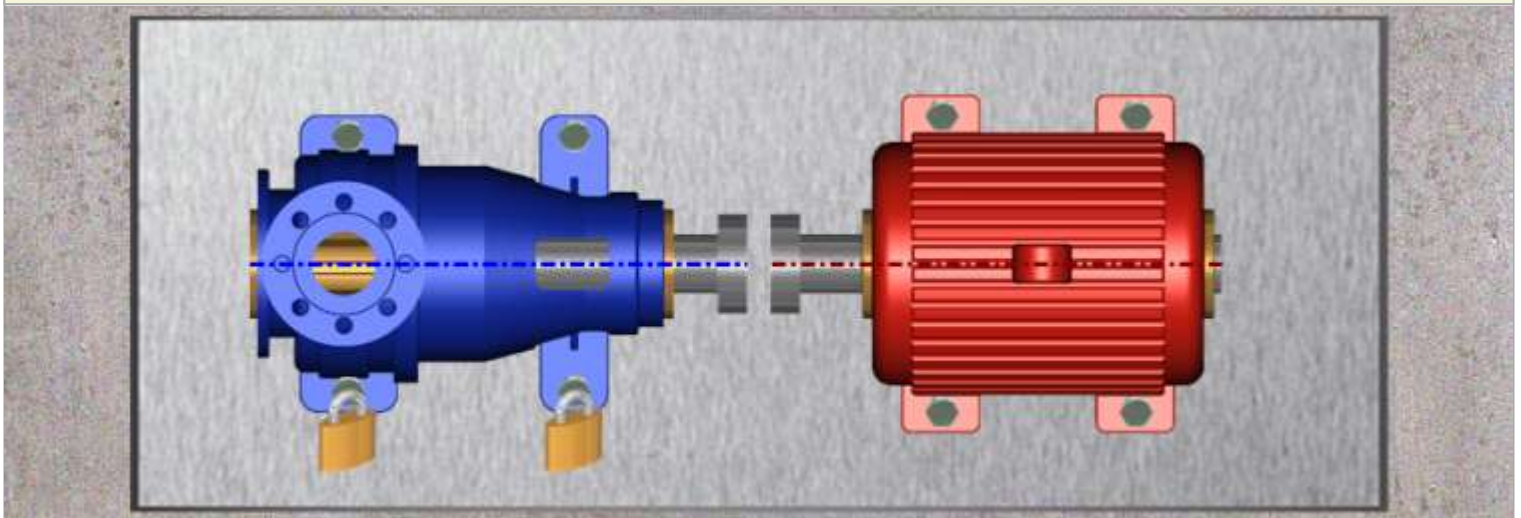
TOP VIEW / HORIZ.

GAP

0.03

RPM	TOLERANCES	
	ACCE...	EXCEL...
1200+		
OFFSET	0.10	0.06
ANGLE	0.08	0.05
GAP	0.13	0.08

OFFSET

0.01

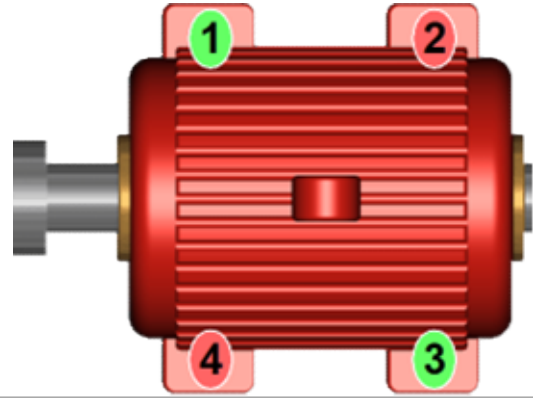
SOFT FOOT

FOOT	TIGHT	LOOSE	CHAN...	NOTES
1	-1.89	-1.88	0.01	
2	-5.09	-4.99	0.11	
3	-5.09	-5.11	-0.02	
4	-1.88	-1.68	0.21	*SHIM
