COUPLE6 ALIGNMENT REPORT

Machine Name MOTOR PUMP 160KW. PP3
Company Name Amita Thailand
Location
Address

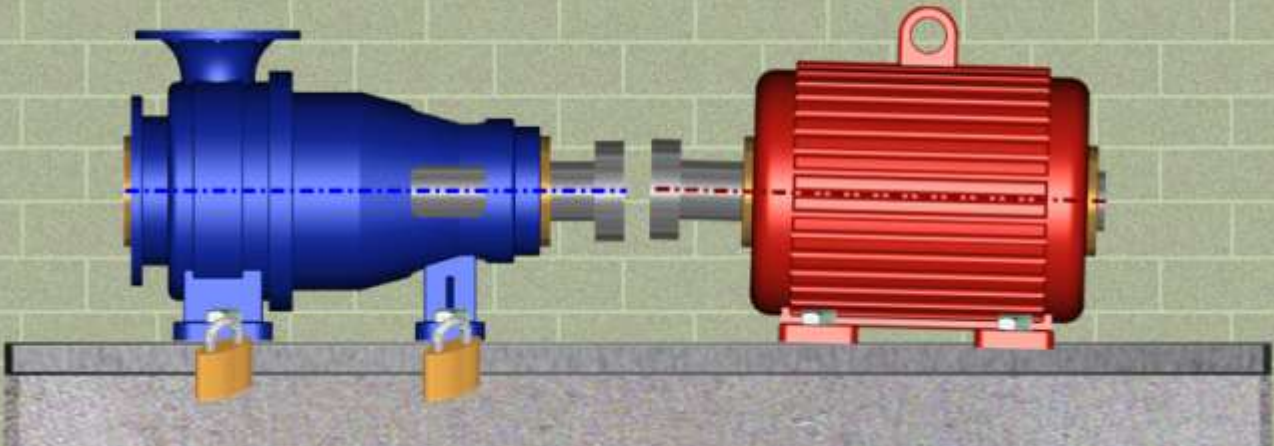
SIDE VIEW / VERT.

GAP

-0.04

RPM	TOLERANCES	
	ACCE...	EXCEL...
1200+		
OFFSET	0.10	0.06
ANGLE	0.08	0.05
GAP	0.13	0.08

OFFSET

0.02

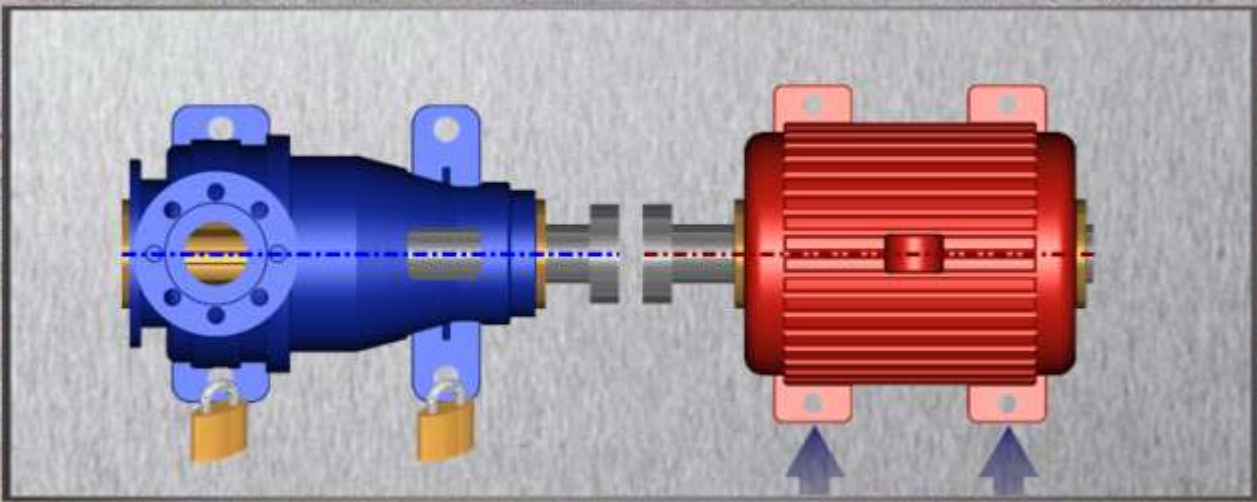
TOP VIEW / HORIZ.

GAP

0.04

RPM	TOLERANCES	
	ACCE...	EXCEL...
1200+		
OFFSET	0.10	0.06
ANGLE	0.08	0.05
GAP	0.13	0.08

OFFSET

0.19
