COUPLE6 ALIGNMENT REPORT

Machine Name MOTOR PUMP 132KW.CDP-1
Company Name Amita(Thailand)
Location
Address

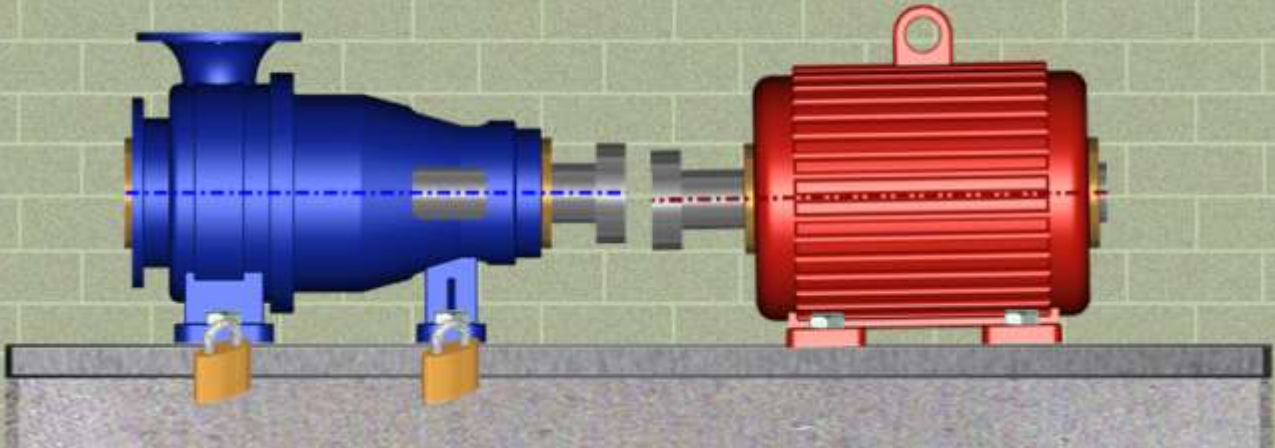
SIDE VIEW / VERT.

GAP

0.03

RPM	TOLERANCES	
	ACCE...	EXCEL...
1200+		
OFFSET	0.10	0.06
ANGLE	0.08	0.05
GAP	0.14	0.09

OFFSET

-0.07

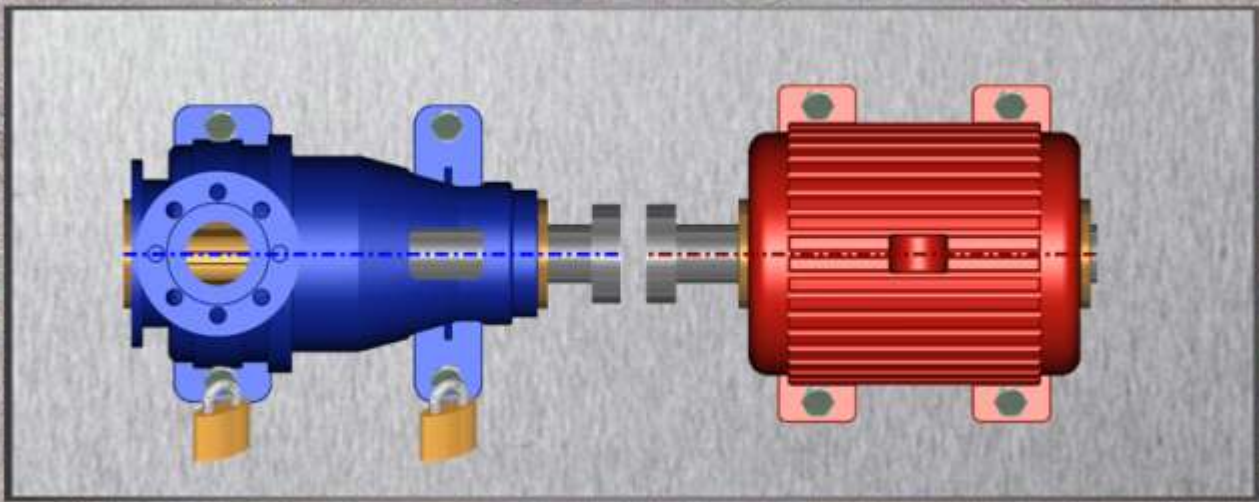
TOP VIEW / HORIZ.

GAP

0.07

RPM	TOLERANCES	
	ACCE...	EXCEL...
1200+		
OFFSET	0.10	0.06
ANGLE	0.08	0.05
GAP	0.14	0.09

OFFSET

-0.03

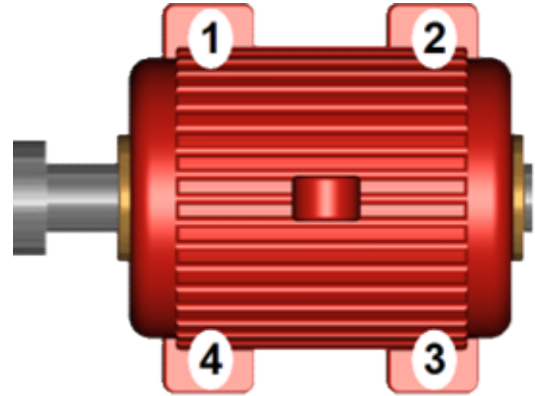
SOFT FOOT

FOOT	TIGHT	LOOSE	CHAN...	NOTES
1	---	---	---	N/A
2	---	---	---	N/A
3	---	---	---	N/A
4	---	---	---	N/A
